Corrosion Resistance of Alternative Reinforcing Bars: An Accelerated Test

Final Report

24 July 2006

WJE No. 2006.0773

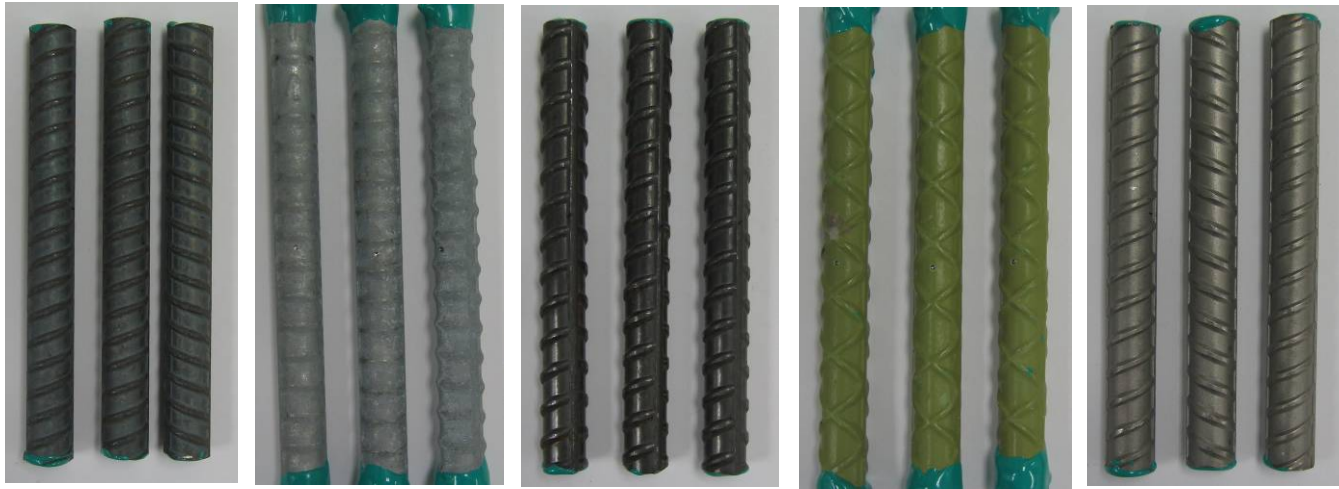
Figure 1. Condition of selected bars before exposure. From left to right: A615-as received; Galvanized-Type B-hole; A1035-as received; ECR-Type B-hole; and 2205-as received.

For solid bars, as-received specimens were tested when possible. Among them, as-received A615 and A1035 bars had as-rolled mill scales while stainless steel 316LN and 2205 were pickled by the manufacturer. Picking is a process which removes mill scales by chemical reactions. Because the surface condition of as-received stainless steel 3Cr12 and 2201 varied from bar to bar with different amount of rust, these bars were sandblasted to achieve comparable surface between replicates. A615 and A1035 bars were also tested in sandblasted condition for comparison. Figure 1 shows appearance of selected bars before the exposure commenced.

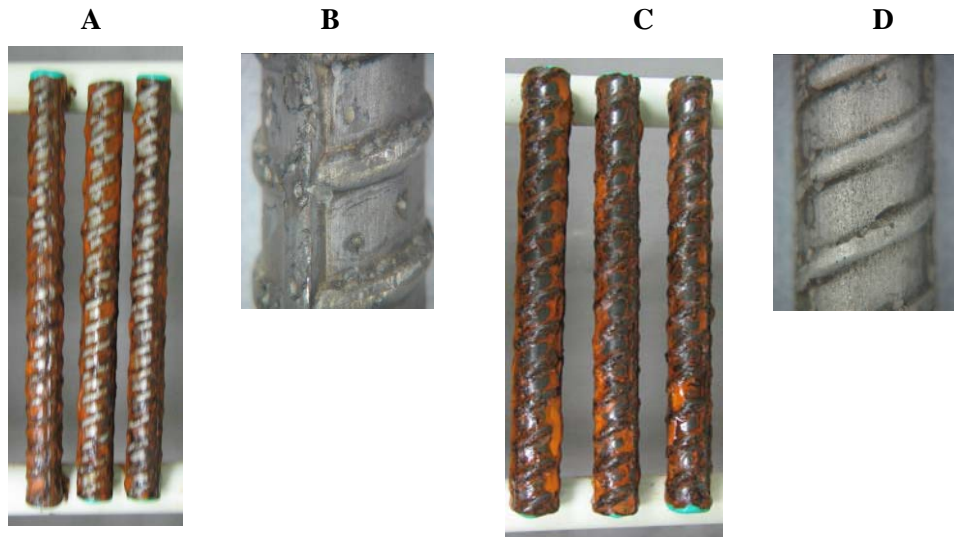
Figure 3. Appearance of A1035 bars after 174 hours of exposure. A) as-received; B) as-received after cleaning; C) sandblasted; D) sandblasted after cleaning

Both as-received and sandblasted bars corroded significantly and corrosion progressed quickly with time. In both conditions, as illustrated in Figure 3, corrosion often took the form of deep pitting. Some pits had depths as high as 1 mm (measured with micrometer, one was 1mm and many were in the order of 0.5mm) after 440 hours of exposure. The average corrosion rate of metal loss were 625 and 523.6 $\mu\text{m}/\text{year}$ for as received and sandblasted bars, respectively, which are about 60 percent of that of as received A615 bars.

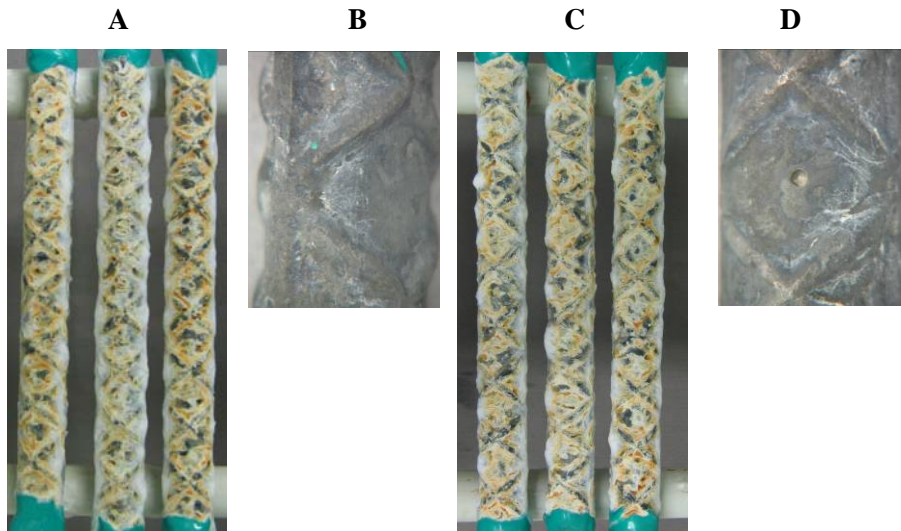
Figure 4. Appearance of Type A galvanized bars after 174 hours of exposure. A) no hole; B) no hole after cleaning; C) with a hole; D) with a hole after cleaning

Weight loss analysis showed that these galvanized bars experienced extensive corrosion with very high corrosion rates. Average corrosion weight loss of the undamaged (Type A) galvanized bars, for example, was 1330 $\mu\text{m}/\text{year}$ which is about 30 percent higher than that of the as-received A615 bars. Figure 4 shows the appearance of the Type A galvanized bars after 174 hours of exposure. Photos of pre-damaged (Type B) bars are documented in the appendix.

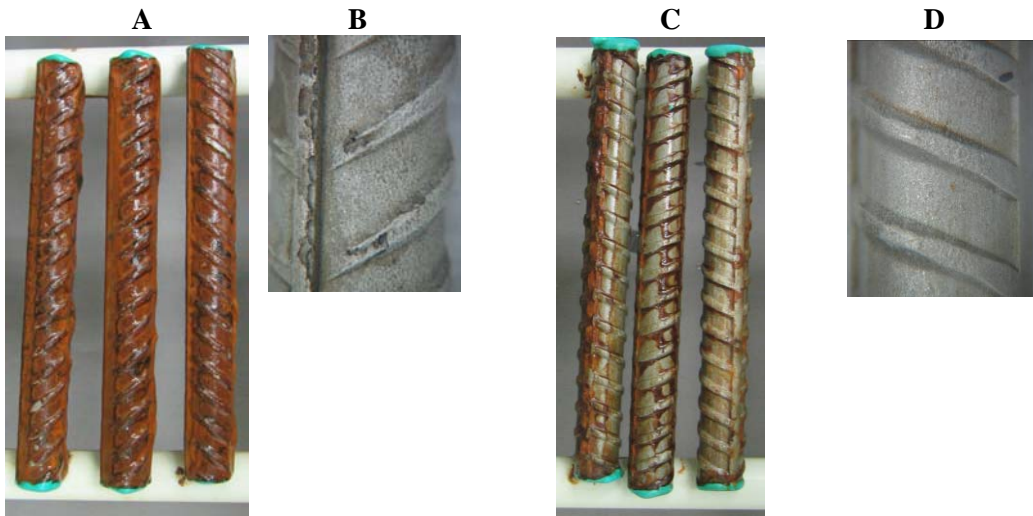
Figure 5. Appearance of stainless steel 3Cr12 and 2201 after 174 hours of exposure. a) 3Cr12; b) 3Cr12 after cleaning; c) 2201; d) 2201 after cleaning

Soon after exposure started, as shown in Figure 5, surfaces of the sandblasted bars assumed a largely uniformly rusty color. After cleaning, it was observed that the bars experienced general corrosion attack at most areas and also some deep pitting corrosion near ribs. While corrosion of 3Cr12 appeared to be extensive, its average corrosion was just $\sim 300 \mu\text{m}/\text{year}$, half of the A1035 and about 1/3 the rate of the as-received A615 steel bars.

After 12 hours of exposure, as shown in Figure 5, corrosion products were visible on most of the bar surfaces and corrosion progressed with time. However, the cleaned bar showed that corrosion was rather superficial and no obvious pits were observed. Weight loss analysis yielded a very low average corrosion of 29.7 $\mu\text{m}/\text{year}$, which is about 3% of as-received A615 bars.

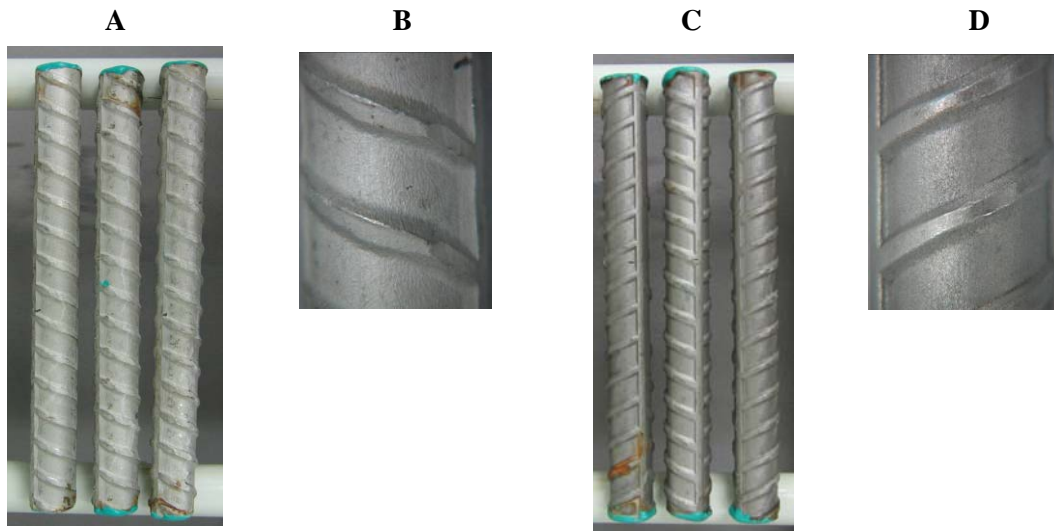
Figure 6. Appearance of stainless steel 316LN and 2205 after 174 hours of exposure. A) 316LN; B) 316LN after cleaning; C) 2205; D) 2205 after cleaning

speculated to have been induced by local contamination or crevices generated by the coating used to seal cut ends. The estimated corrosion rates were lower than $2 \mu\text{m}/\text{year}$ for both materials. Surface condition of these bars after 174 hours of exposure is shown in Figure 6.

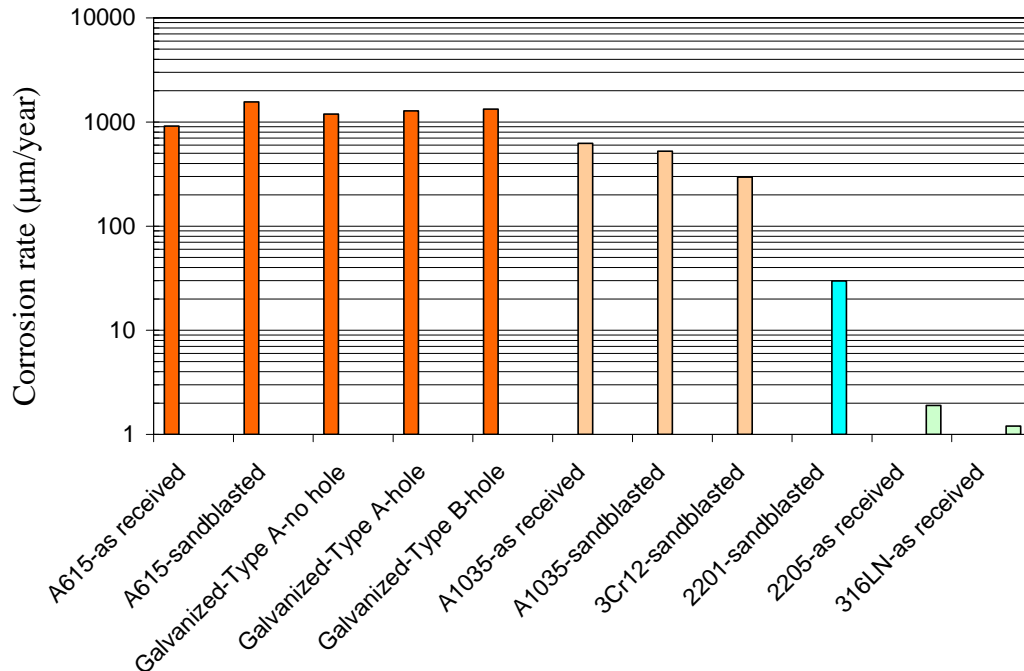
Figure 8. Average corrosion rates of various reinforcing bars. The method using weight loss data to determine corrosion rate was not applicable to epoxy-coated rebar (ECR). Corrosion rate of ECR, however, was minor and estimated to be in the same order as stainless steel 316LN and 2205.

Table A1 summarizes the weight loss and estimated corrosion rate data, which are illustrated in Figure 8. The corrosion rate ratios compared to the least corroded bars (316LN) are also included in this table. The bars can be divided into 4 groups based on their average corrosion rates:

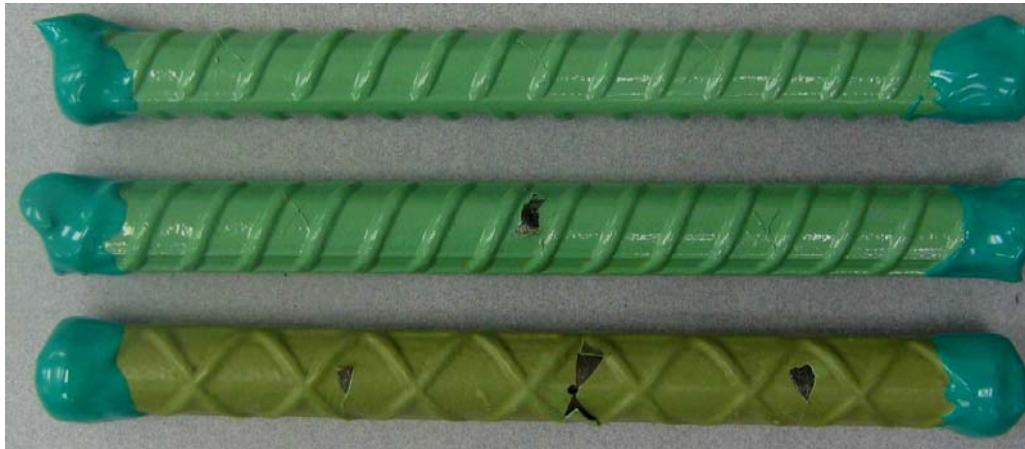
Figure 9. Knife adhesion test of Epoxy-coated bars after 4 weeks of exposure. From top to bottom: ECR-Type A-no hole; ECR-Type A-hole; ECR-Type B-hole

Table A2 summarizes the adhesion of the epoxy coating before and after being tested in the salt-spray chamber for up to 4 weeks. The recently coated bars (ECR-Type A) only lost some adhesion (1 to 1.5 points) at the drilled holes while the coating remained well bonded to the steel away from the drill holes. Likewise, the bars (ECR-Type B) extracted from the Chicago deck showed some adhesion loss at drilled holes (about 1.5 points) while adhesion at areas away from the holes remained largely unchanged. Figure 9 shows the knife adhesion results of three epoxy-coated bars after up to 4 weeks of exposure. All the three bars removed from the deck, including the two that had low adhesion before exposure, were largely corrosion-free except for localized corrosion at existing defects.

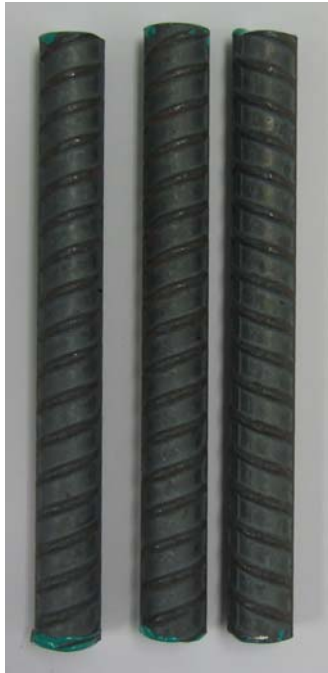
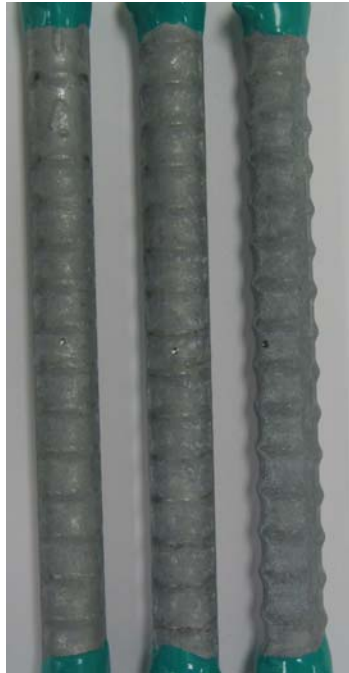
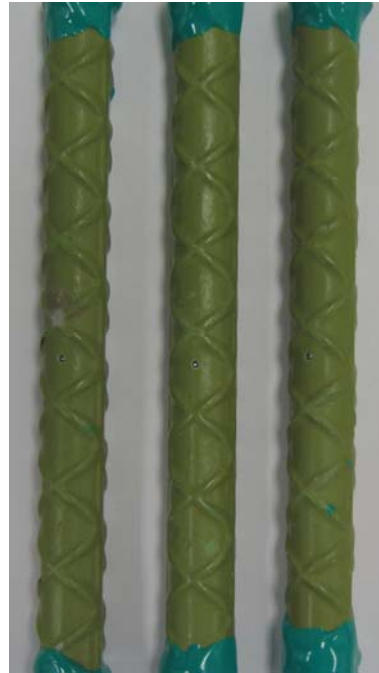
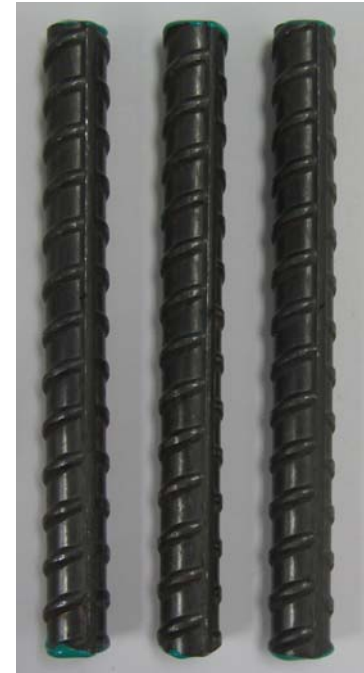
Figure A1. Surface condition of
bars before exposure

A615-as received 3Cr12-sandblasted

Galvanized-Type B-hole 2201-sandblasted

ECR-Type B-hole 316-as-received

A1035-as received 2205-as received

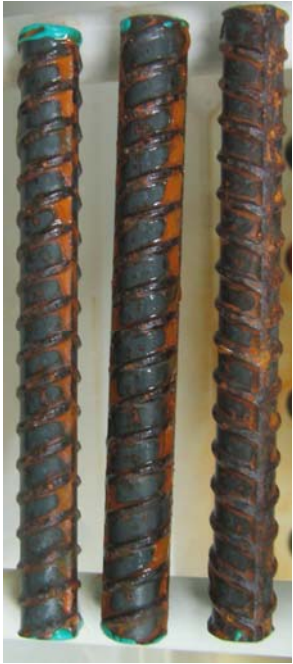
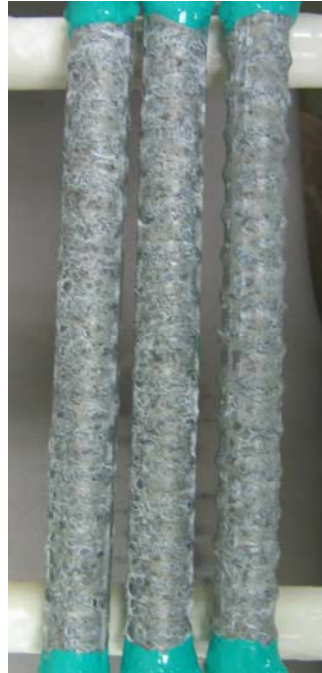
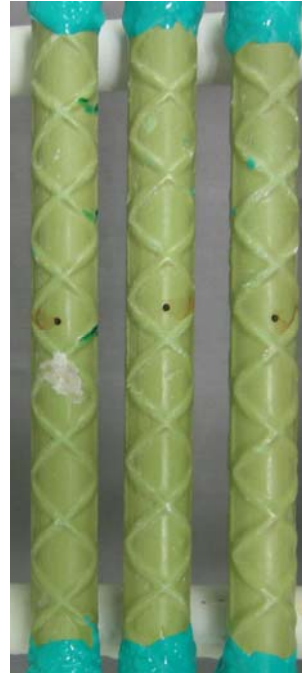
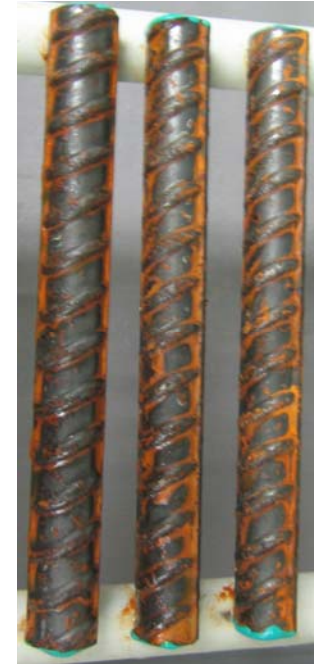
Figure A2. Surface condition of bars after 12 hours of exposure

A615-as received Galvanized-Type B-hole
3Cr12-sandblasted 2201-sandblasted

ECR-Type B-hole
316-as-received

A1035-as received
2205-as received

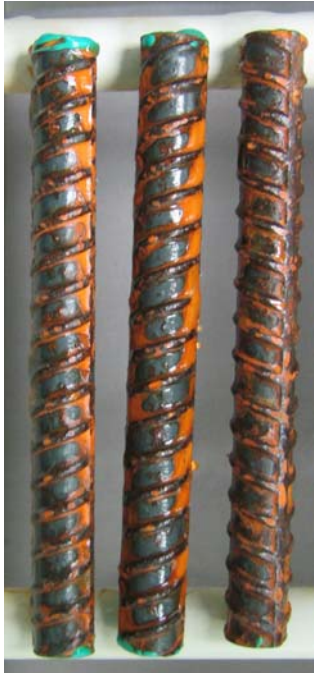
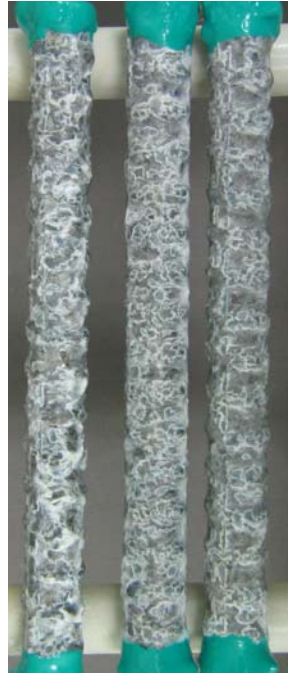
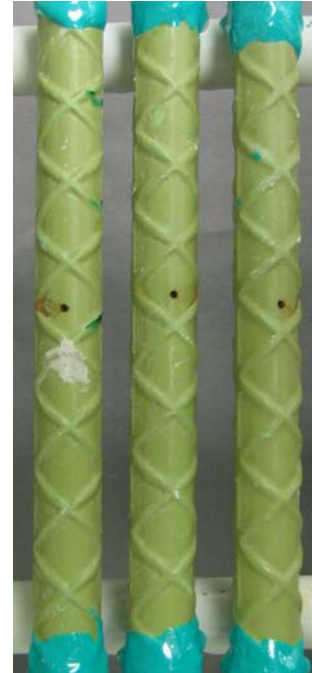
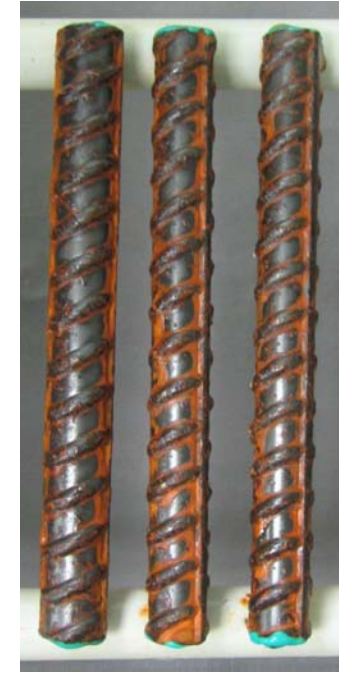
Figure A3. Surface condition of bars after 30 hours of exposure

A615-as received Galvanized-Type B-hole
3Cr12-sandblasted 2201-sandblasted

ECR-Type B-hole
316-as-received

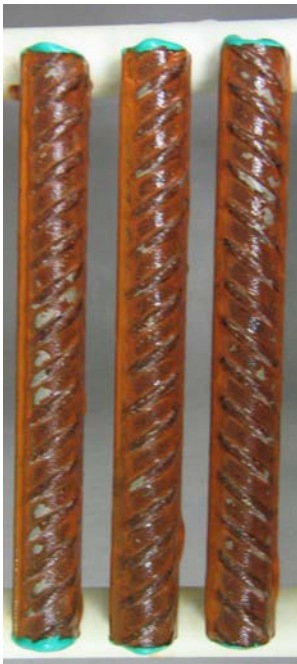
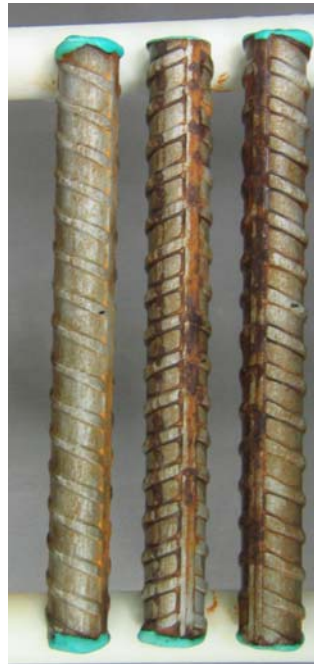
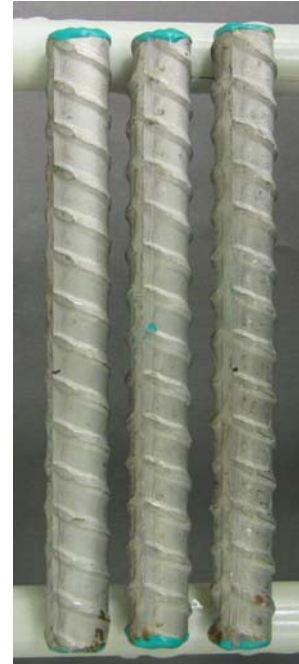
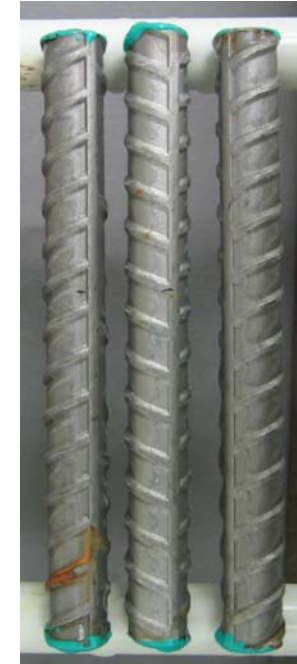
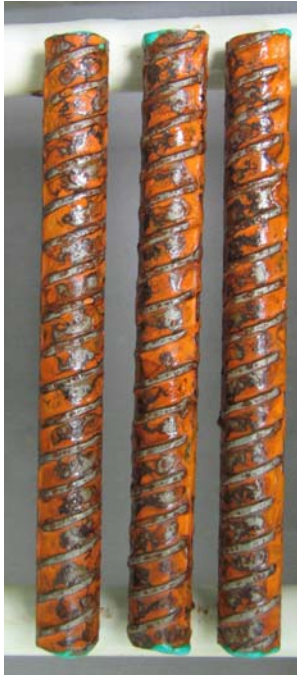
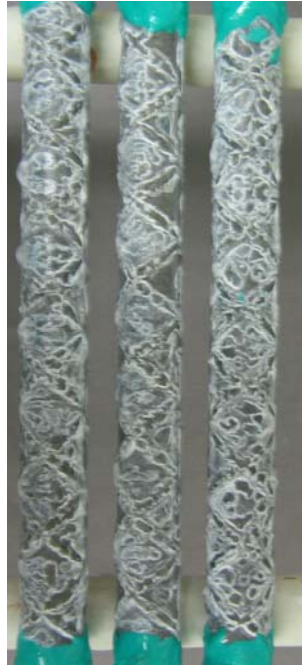
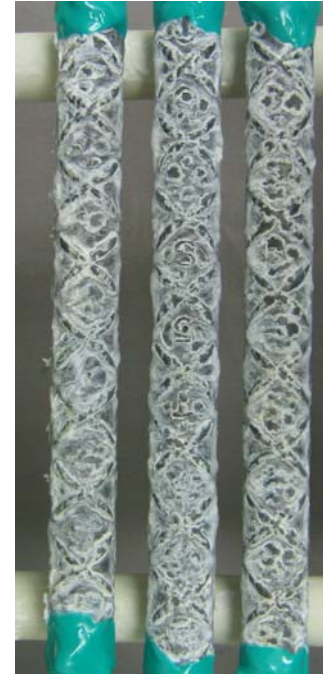
Figure A4. Surface condition of bars after 60 hours of exposure

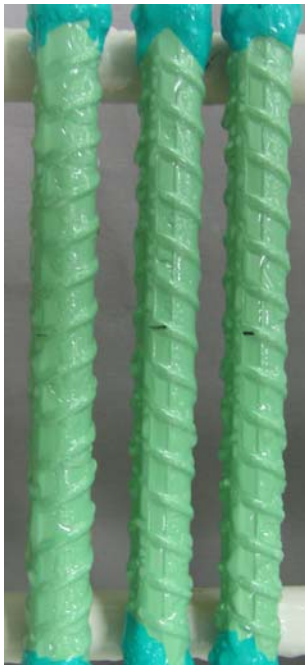
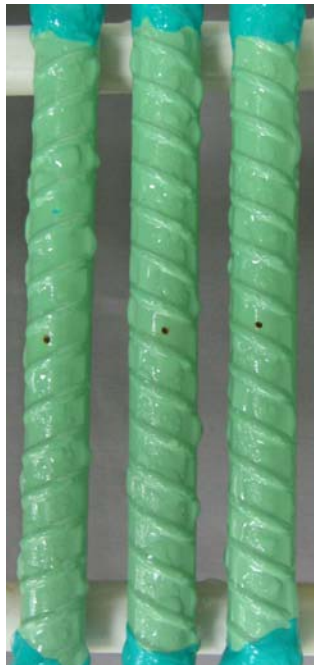
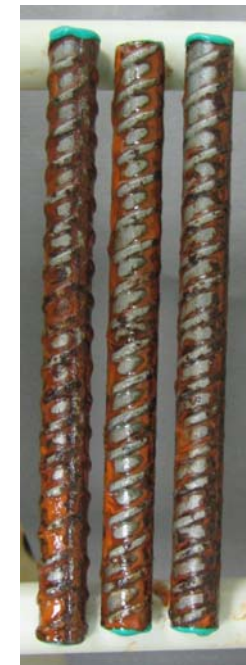
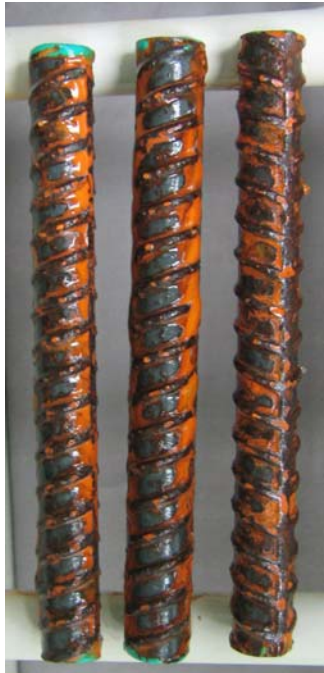
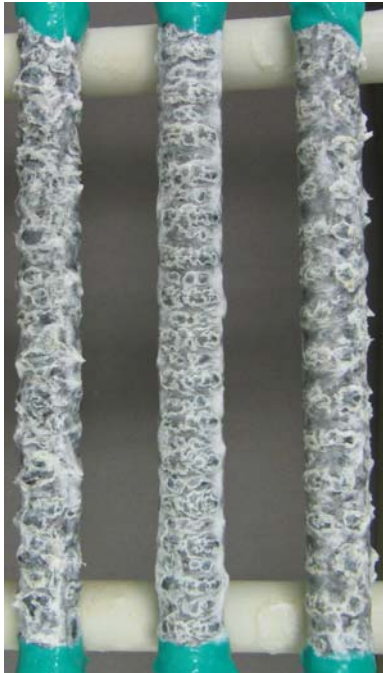
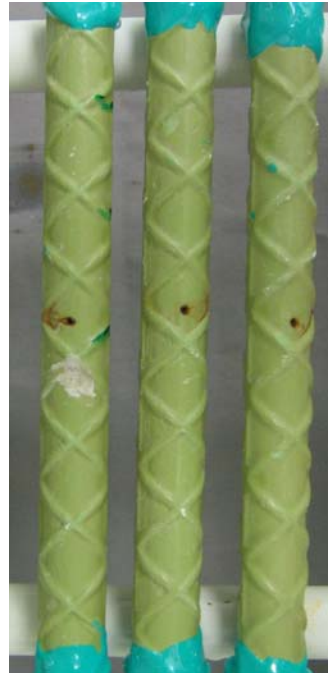
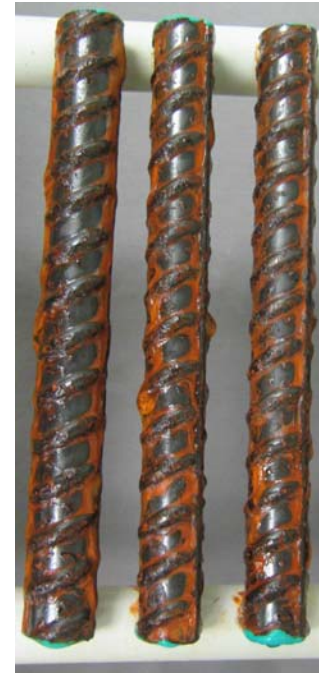
Figure A5. Surface condition of bars after 108 hours of exposure

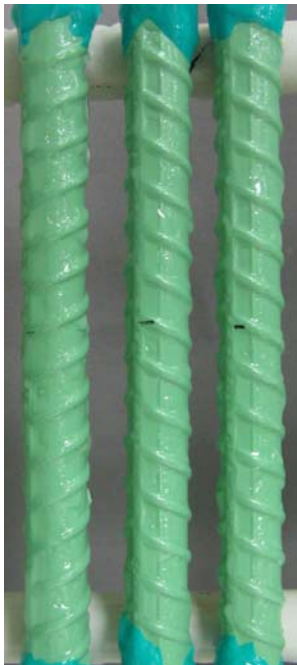
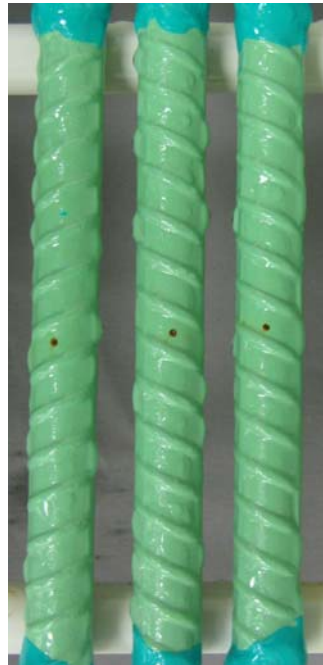
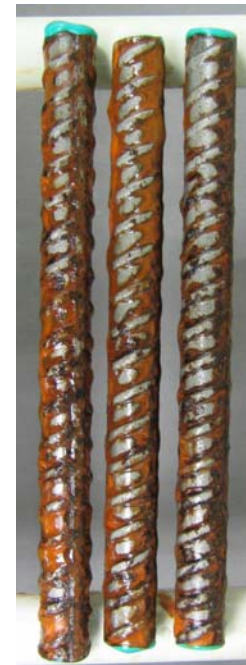
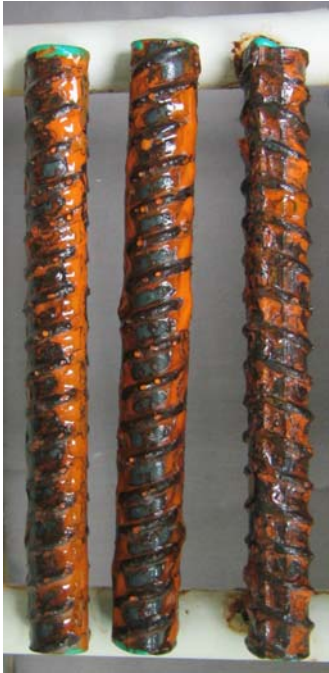
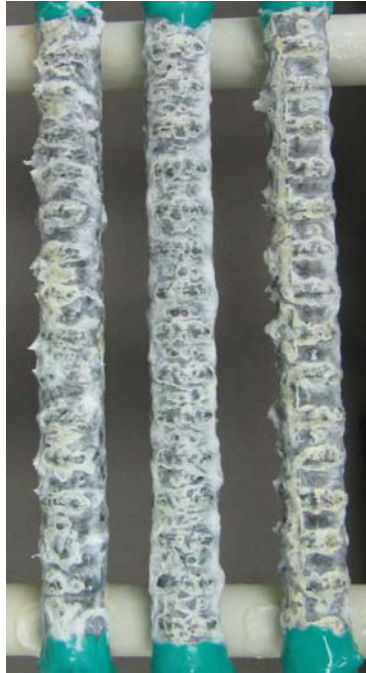
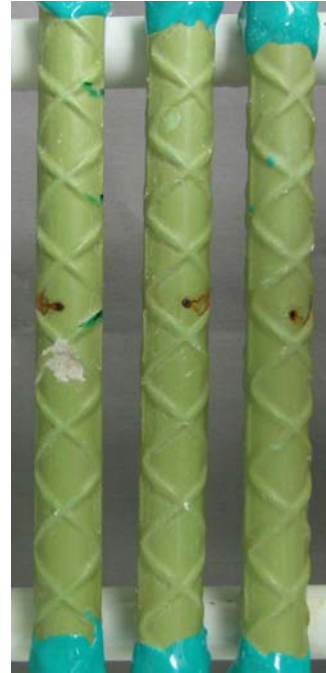
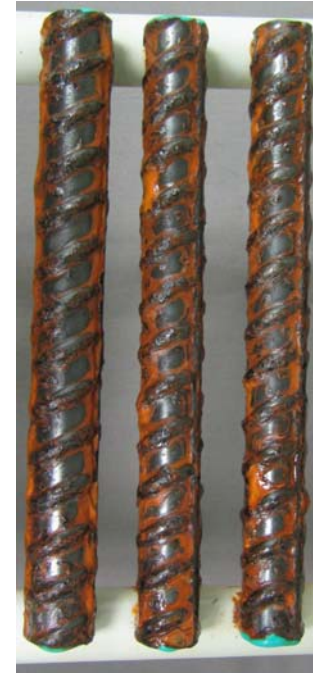
Figure A6. Surface condition of bars after 174 hours of exposure

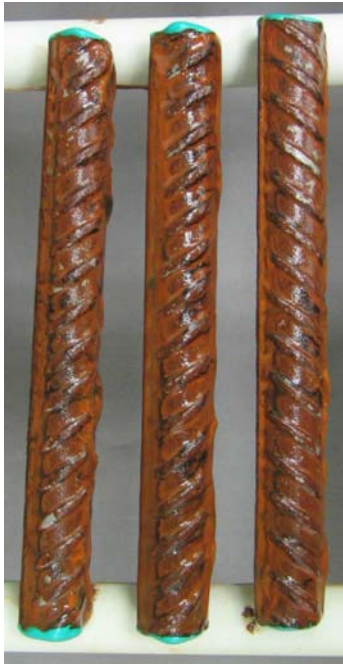
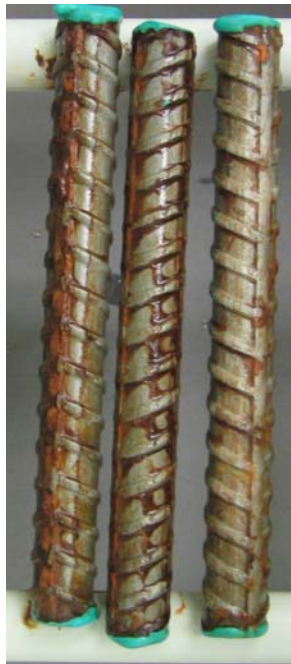
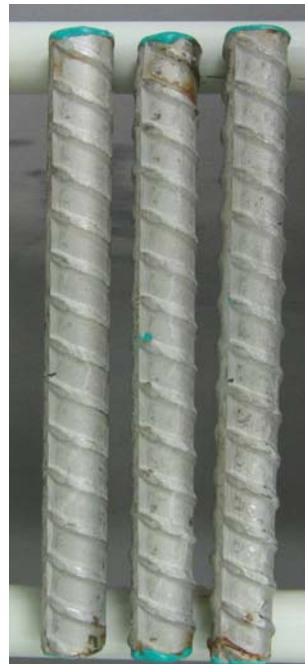
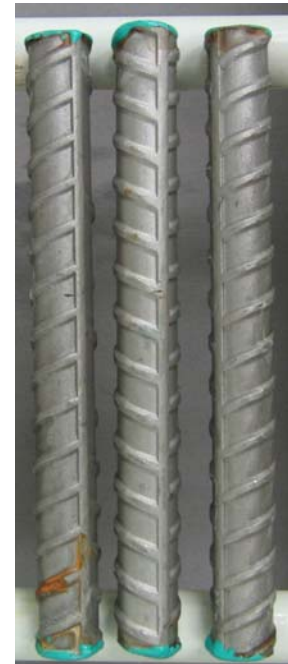
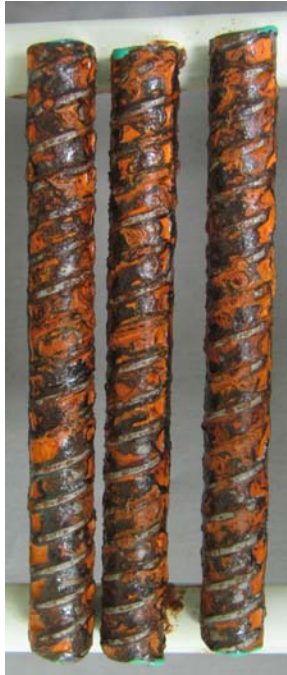
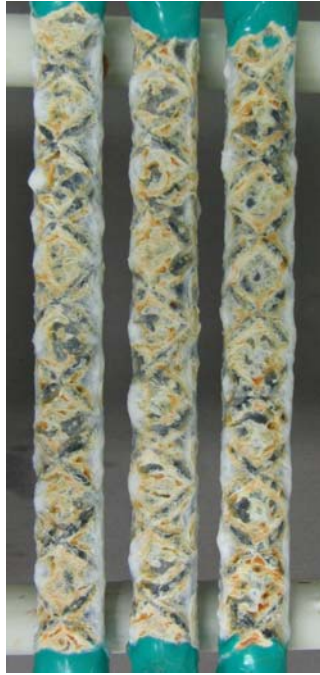
Figure A7. Surface condition of bars after 440 hours of exposure

A1035-as received
2205-as received

A615-sand blasted
ECR-Type A-no hole

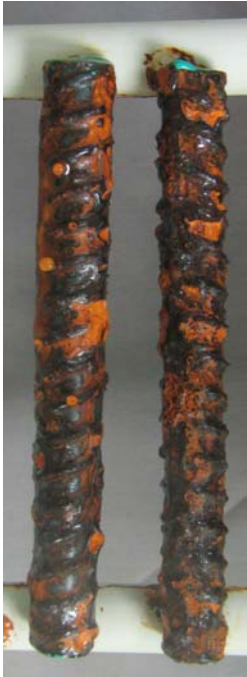
A615-as received

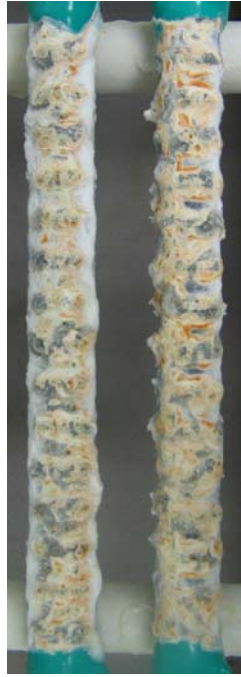
Galvanized-Type B-hole
3Cr12-sandblasted

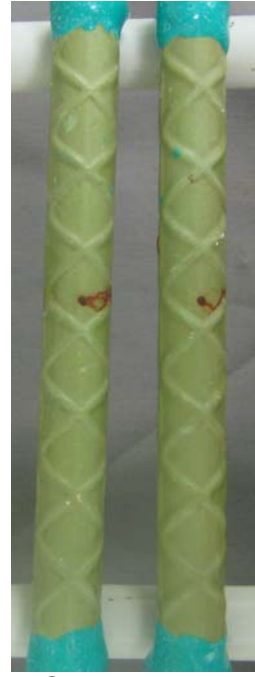
ECR-Type B-hole
316-as-received

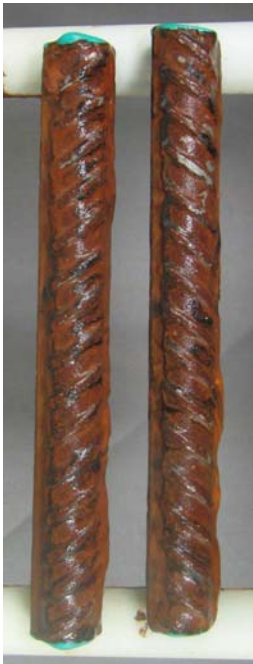
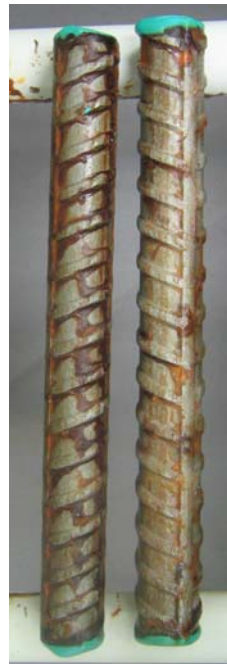
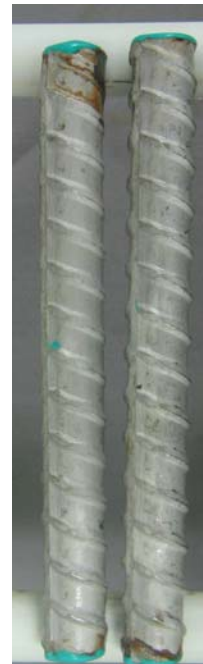
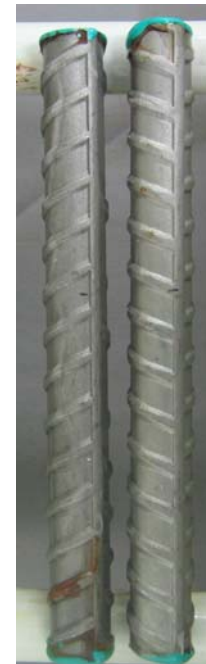
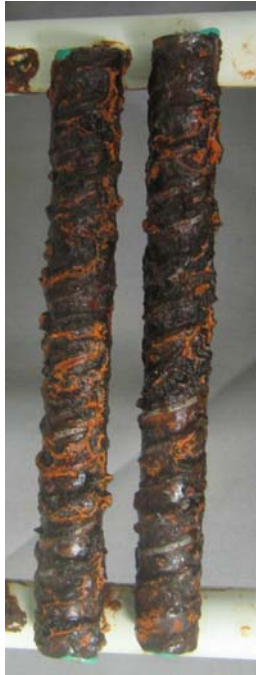
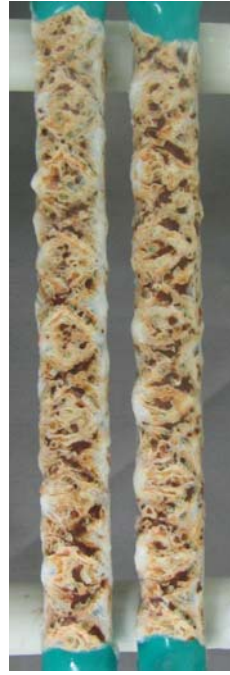
Figure A8. Surface condition of bars after 672 hours of exposure

A1035-as received
2205-as received

A615-sand blasted
ECR-Type A-no hole

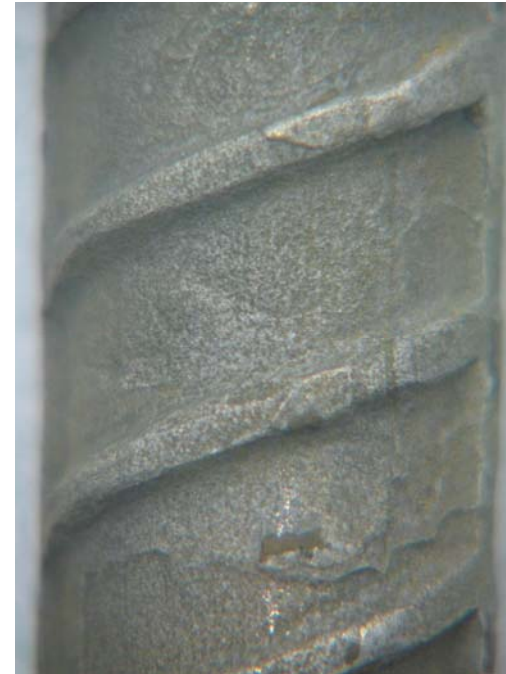
Sandblasted
A615 bar:
extensive
corrosion,
more uniform

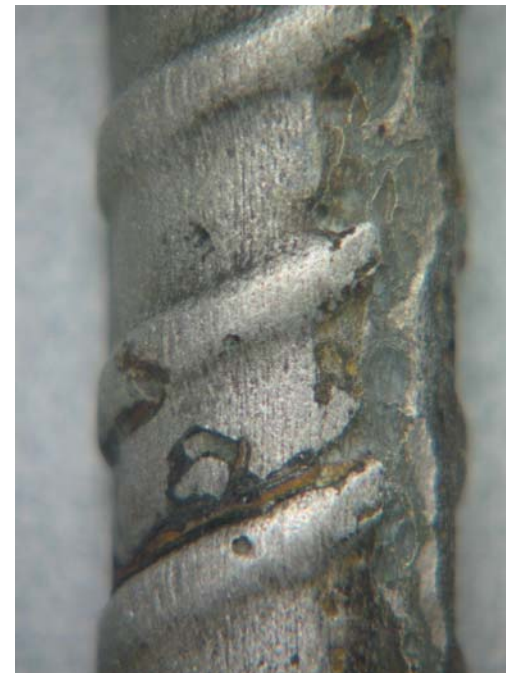
Sandblasted
A1035: broader
pitting attack

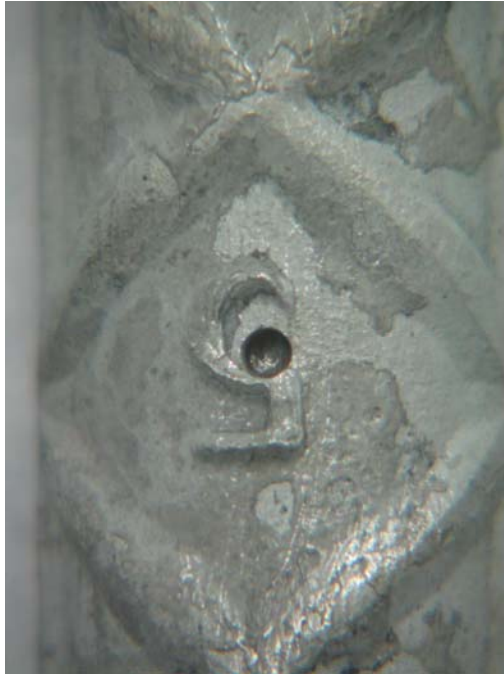
Galvanized-type A:
extensive corrosion, many parts lost Zn coating. Steel in hole was largely protected

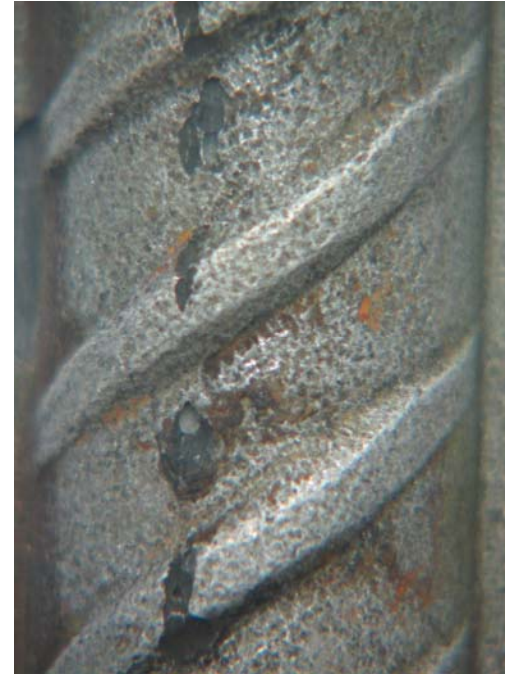
Sandblasted 3Cr12:
extensive corrosion, pits and general

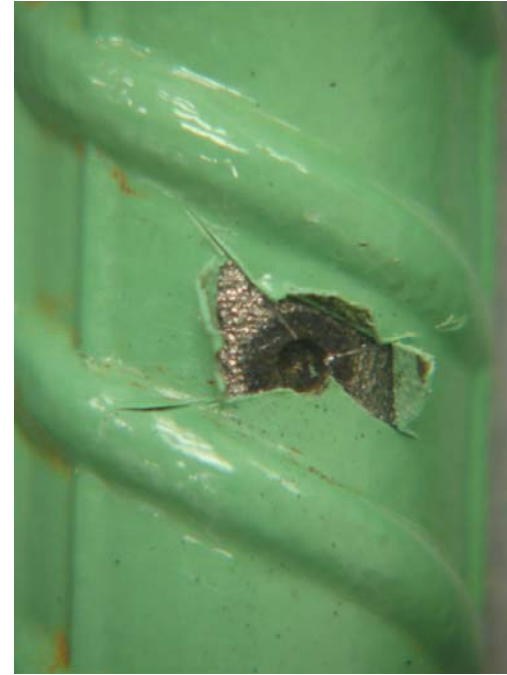
ECR-Type A-
adhesion: dark
area lost
adhesion, rate-
2.5

6. Type A epoxy-coated bars (recently produced) performed very well, corrosion was only observed at drilled holes.
7. Epoxy-coated bars removed from a 15-year old deck performed well during the test. Corrosion was minor and only took place at drilled holes and later at existing defects in the coating. The epoxy coating adhesion did not affect the corrosion performance. Bars with poor coating adhesion performed well in the test.

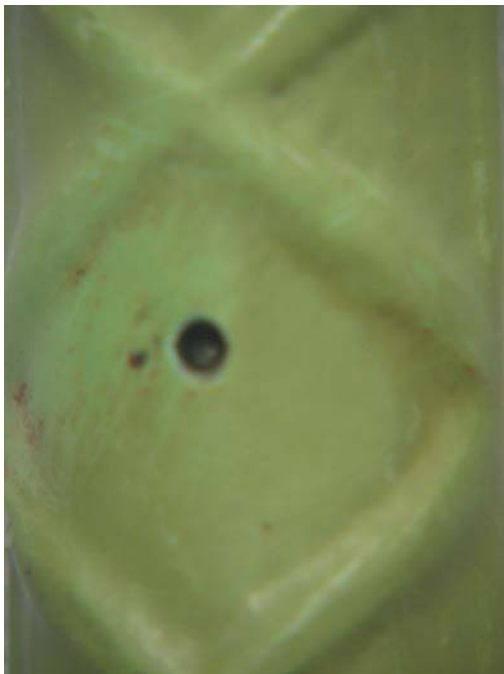
ECR-Type B:
Only steel
exposed at the
drilled hole and
a pre-existing
defect corroded

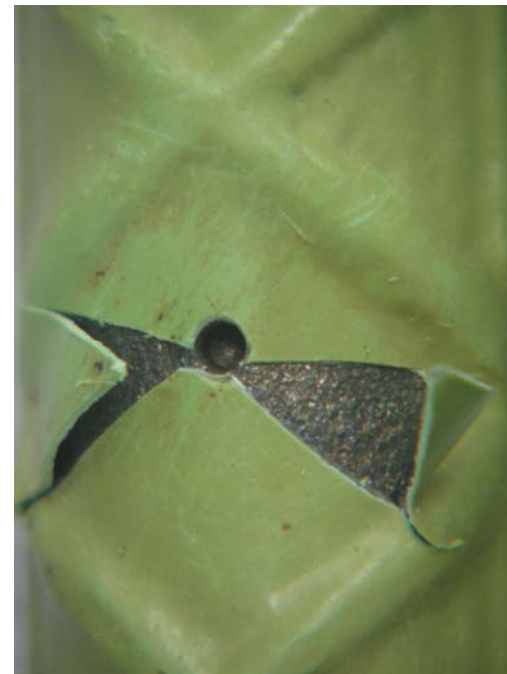
ECR-Type B-
adhesion:
coating easy to
peel: rate-5
